Environmental Impact of Acid Sulfate Soils near Cairns, Qld

Executive Summary of Research Undertaken by
CSIRO Land and Water to March 1999

CSIRO Land and Water
Technical Report 15/99, March 1999

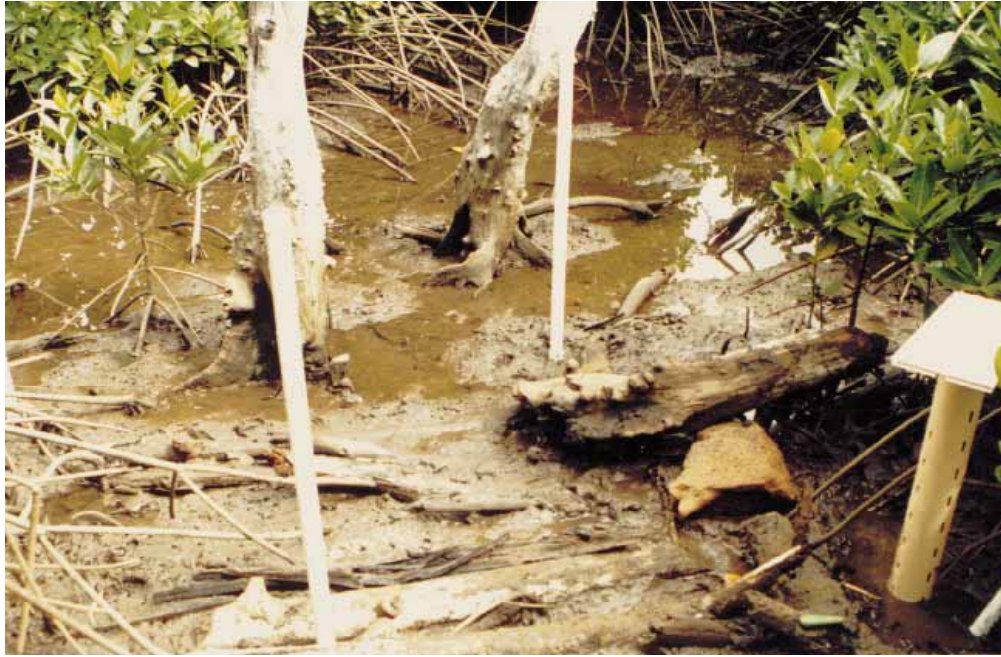
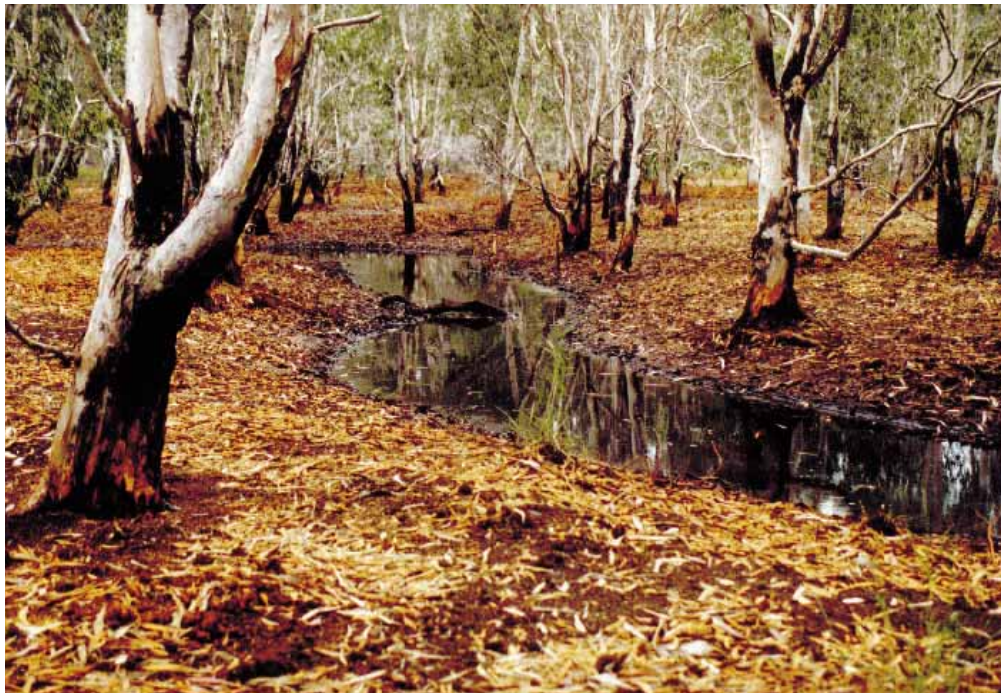
Southernmost end of site, showing the original condition (top) and drained condition (below). Leachate shown in the bottom picture contains a cocktail of toxic elements.

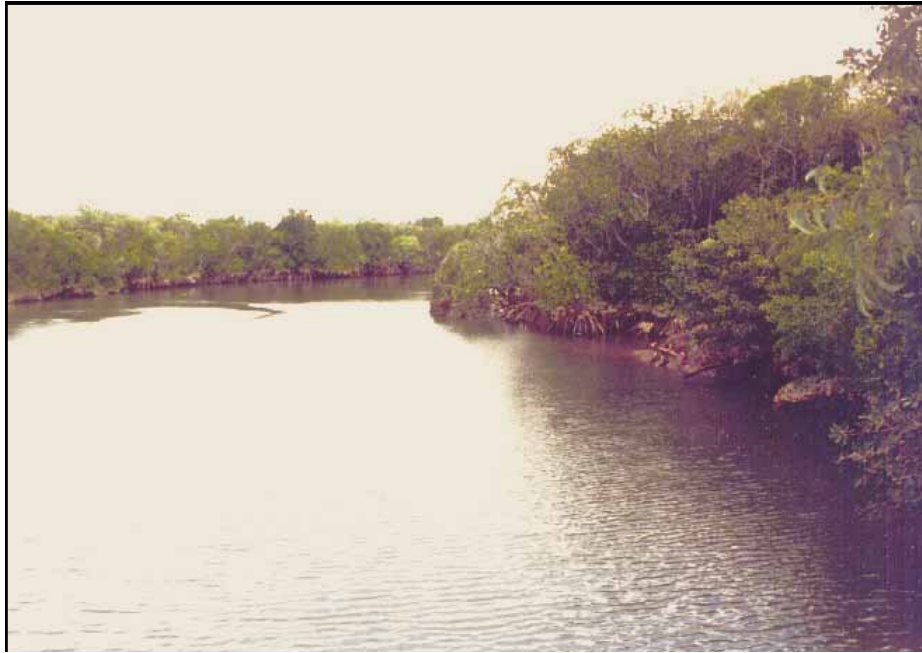
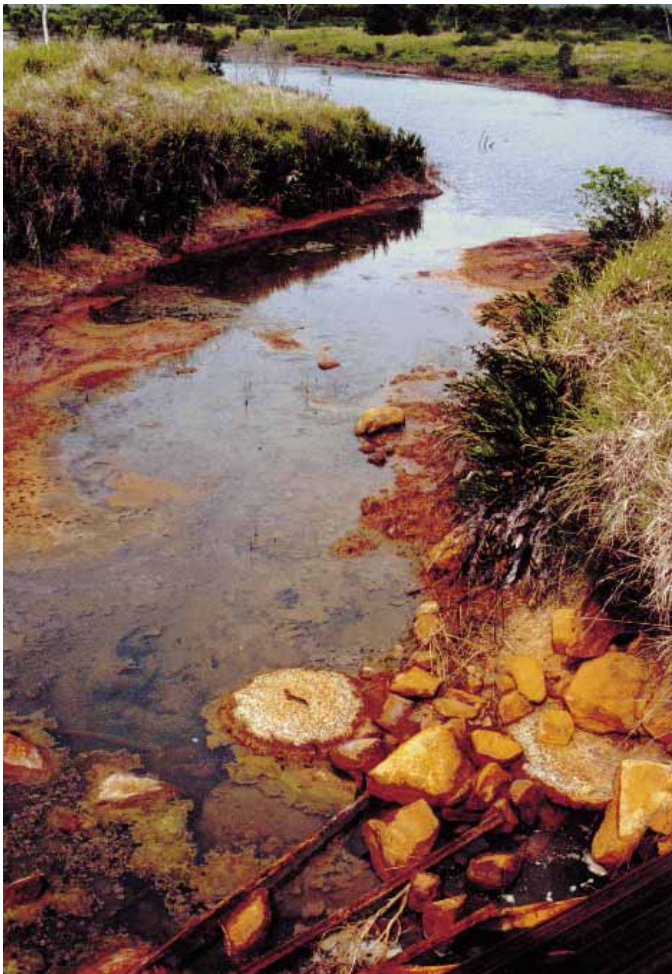
Firewood Creek at discharge point showing channel to Trinity Inlet (top) and drained sections (left). Note corrosion of steel and iron precipitate.

The S-W corner of the bunded area is covered extensive iron precipitates, which extend to about 0.6m below the surface. These precipitates adsorb arsenic and zinc and constitute a highly mobile reservoir of these elements. Measurements indicate that these precipitates contain arsenic at about 300 to 700 mg/kg and zinc from 100 to 500 mg/kg. During the wet season when water levels inside the bund are high, the iron precipitates flush into Trinity Inlet when the tide gates are open. Natural processes in the sediments of the inlet will reduce the iron in the particulate material from its ferric to ferrous state, releasing the adsorbed elements into the surrounding pore waters. The problem is that toxic elements can be taken up by benthic and bottom-feeding organisms.
