# Environmental Impact of Acid Sulfate Soils near Cairns, Qld

Executive Summary of Research Undertaken by  
CSIRO Land and Water to March 1999

CSIRO Land and Water  
Technical Report 15/99, March 1999

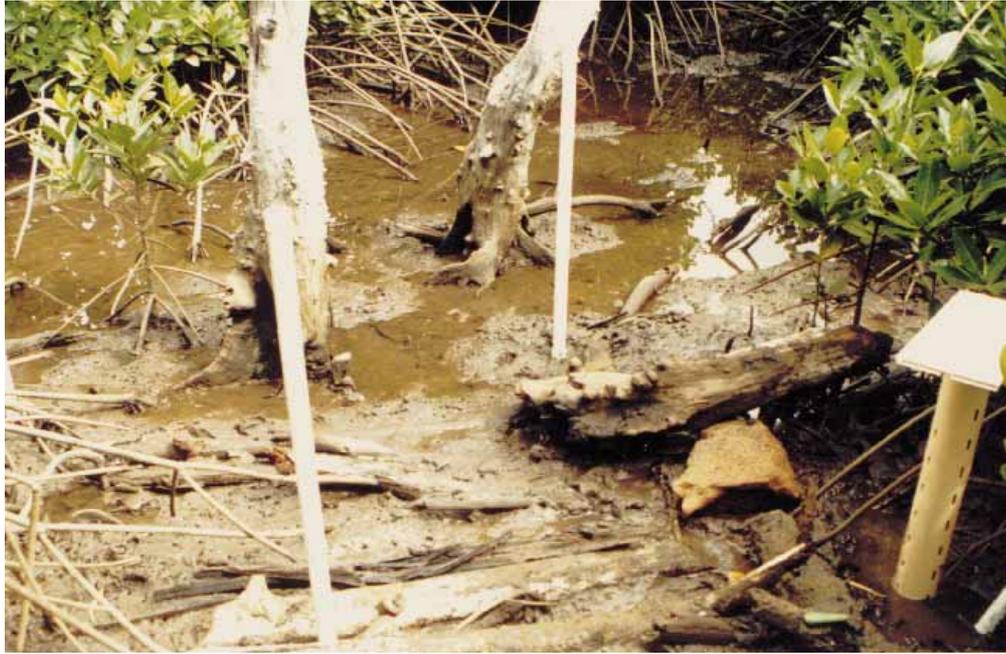
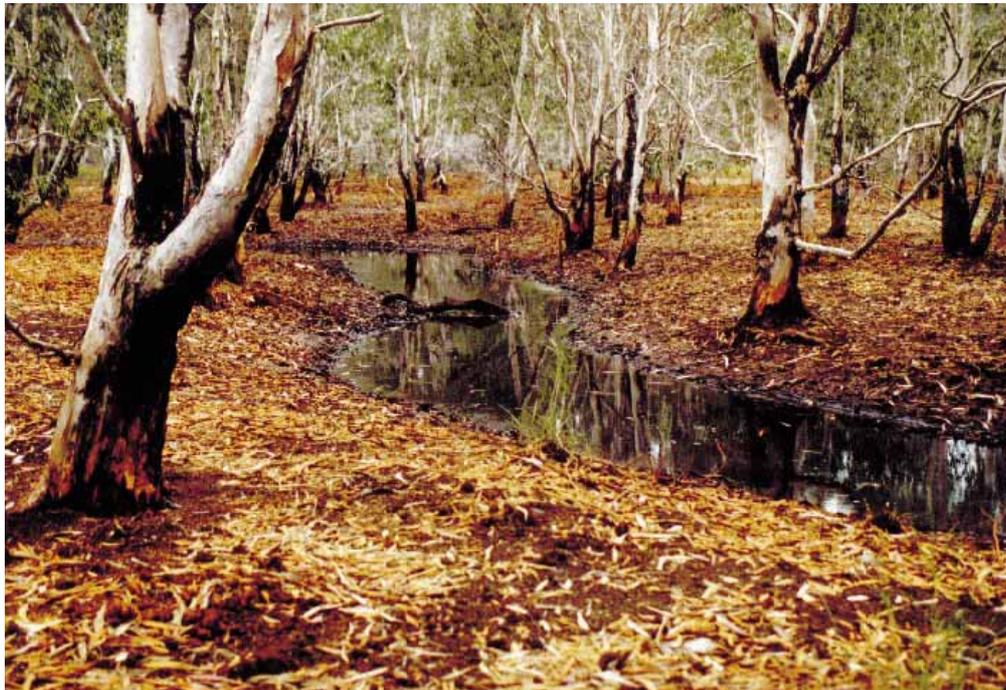
Southernmost end of site, showing the original condition (top) and drained condition (below). Leachate shown in the bottom picture contains a cocktail of toxic elements.

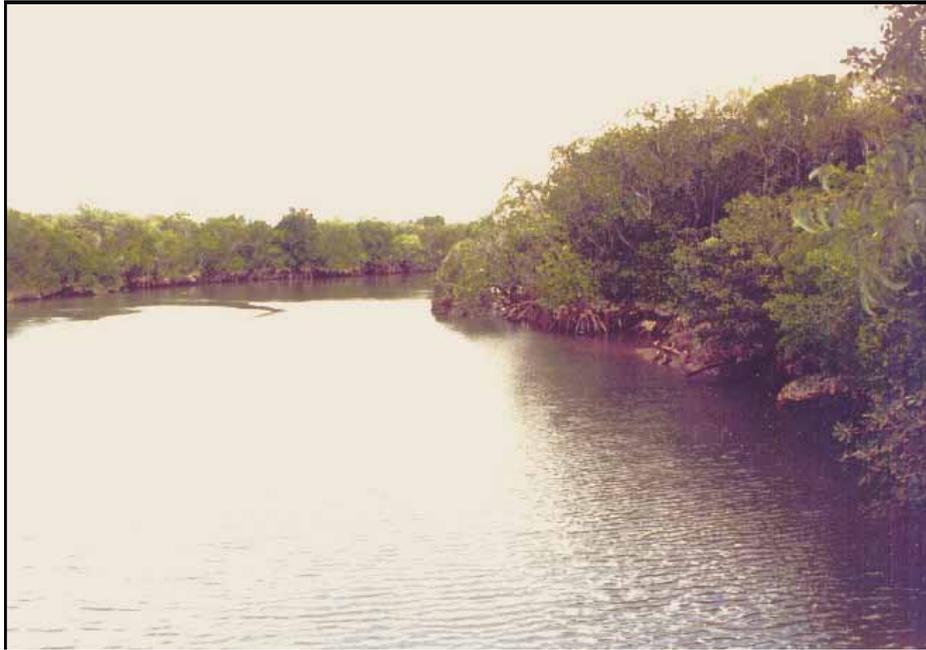
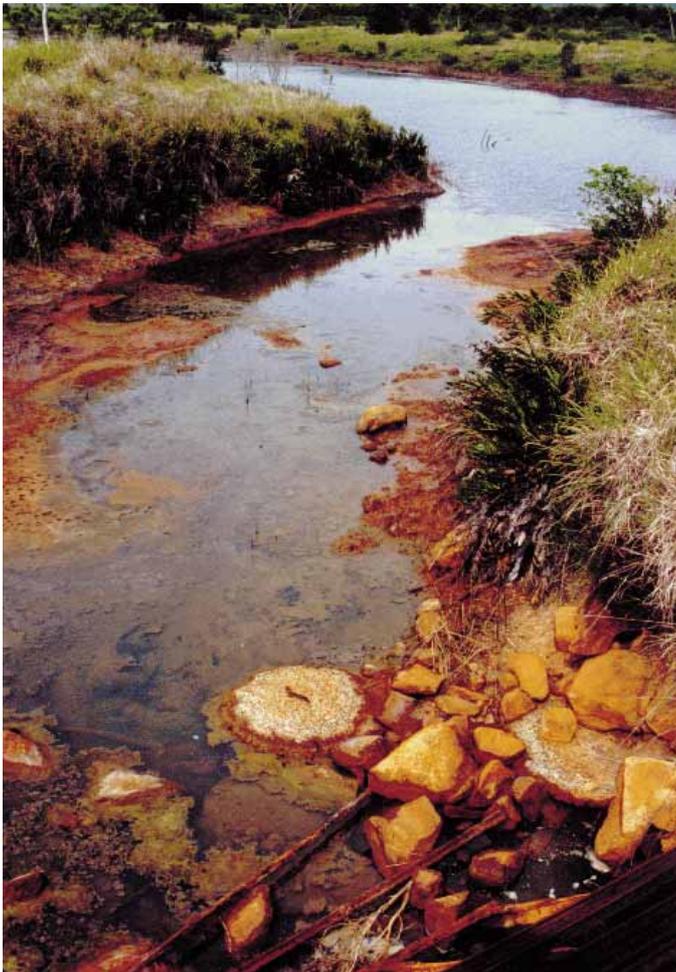
Firewood Creek at discharge point showing channel to Trinity Inlet (top) and drained sections (left). Note corrosion of steel and iron precipitate.
